A Completion Report for:

# PROJECT MAHAMPHY: WEAVERS' WORKSHOP REPAIR AND IMPROVEMENT

Improving the sustainability of *mahampy* reed weaving as a  
women's livelihood

November 2025

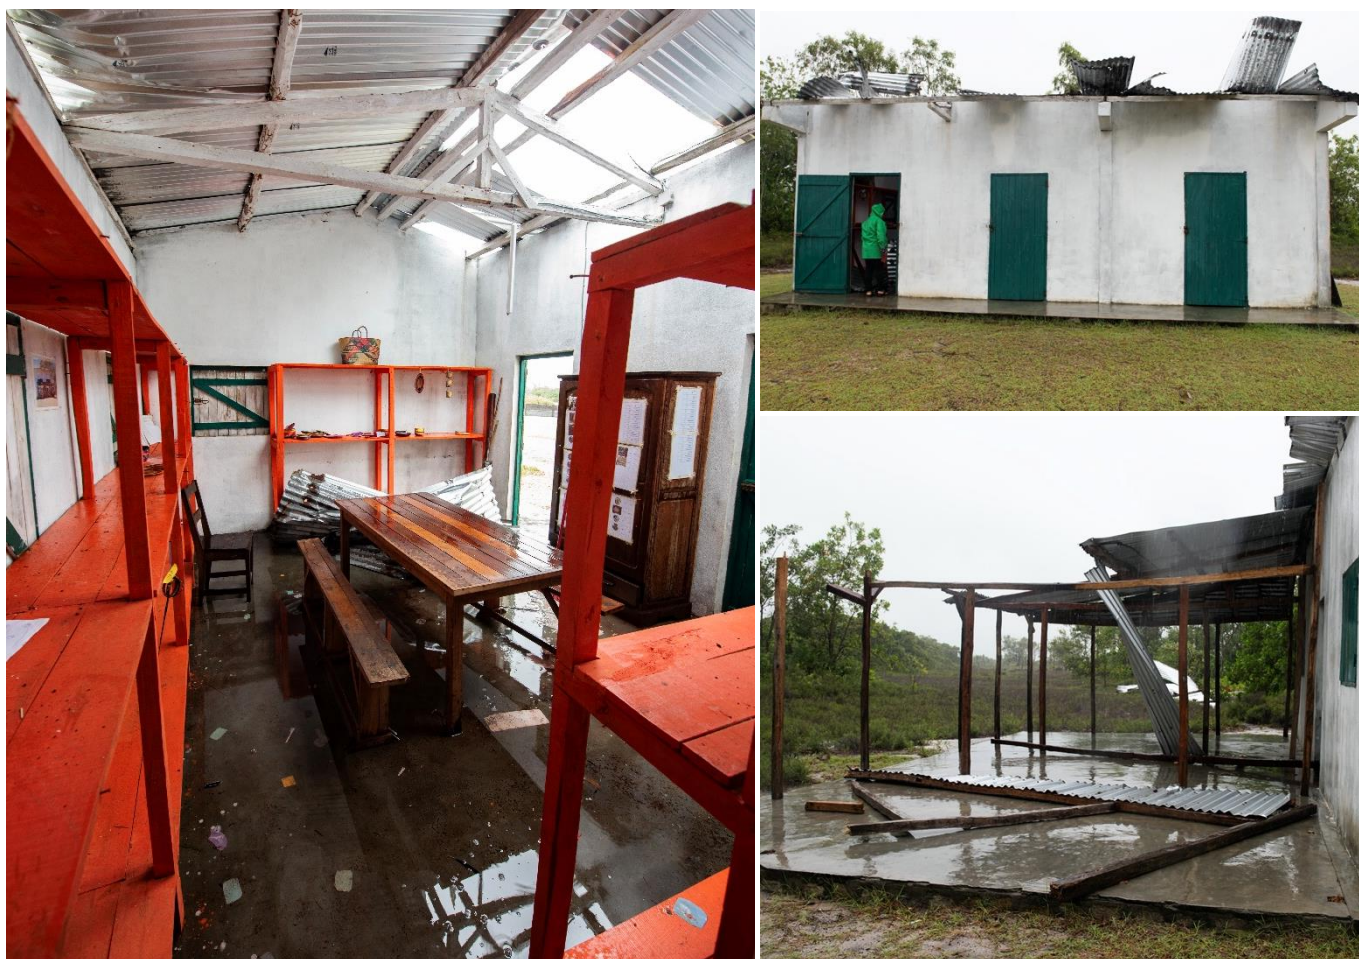
just two months after a devastating fire that damaged vast swathes of the countryside and followed the driest October to December on record. The number and severity of climate-driven extreme weather events are predicted to increase in the future, which, coupled with global aid cuts, will continue to exacerbate the challenges faced by people in the region. The Weavers' Workshop, which acts as the storefront and main point of sale for the Cooperative, was severely damaged in the storm. The metal roof sheeting was torn apart by the high winds, which then allowed heavy rain into the Workshop, destroying most of the products inside. These products represent thousands of hours of work, as well as significant financial investment from the weavers who have to buy the *mahampy* in order to weave their creations. The concrete floor with roof covering the attachment at the back of the Workshop, which was constructed to give the weavers more space to work, also had its roof destroyed. The Workshop's basic solar panel system, which provides electric lighting, sustained some damage and additionally required repairs. The damages resulting from the storm caused the Workshop to close, halting any sales and leaving Cooperative members without a space to work or generate income.

*The Workshop flooded after the storm (left), the front (top right) and back (bottom right) of the Workshop's exterior.*

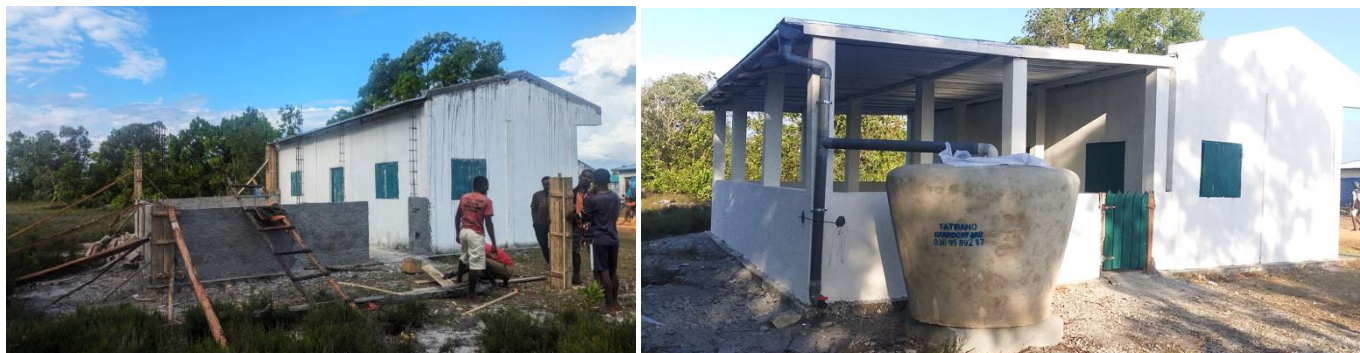
*Construction and repair activities ongoing at the Mahampy workshop building (left) and the building complete with a rainwater harvesting system (right).*

SEED's construction design was updated in 2022 to incorporate cyclone resistant features which includes concrete encasement around the roof's edge, reinforced wooden beams along the ceiling, and strategically layered roofing sheets. In keeping with this design, SEED's construction team fully replaced the Workshop's metal roof in July to protect against further damage in case of future extreme weather events. These measures have enhanced the

Workshop's structural strength and stability, significantly improving its resilience to the increasingly unpredictable adverse weather events driven by climate change.

In September, a 2,000-litre rainwater harvesting system was installed in order to collect rainwater from the new roof, providing access to clean water for cooking, drinking, and handwashing. Previously, the Weavers had to leave the Workshop to collect water, taking time away from their work and impacting their availability for making

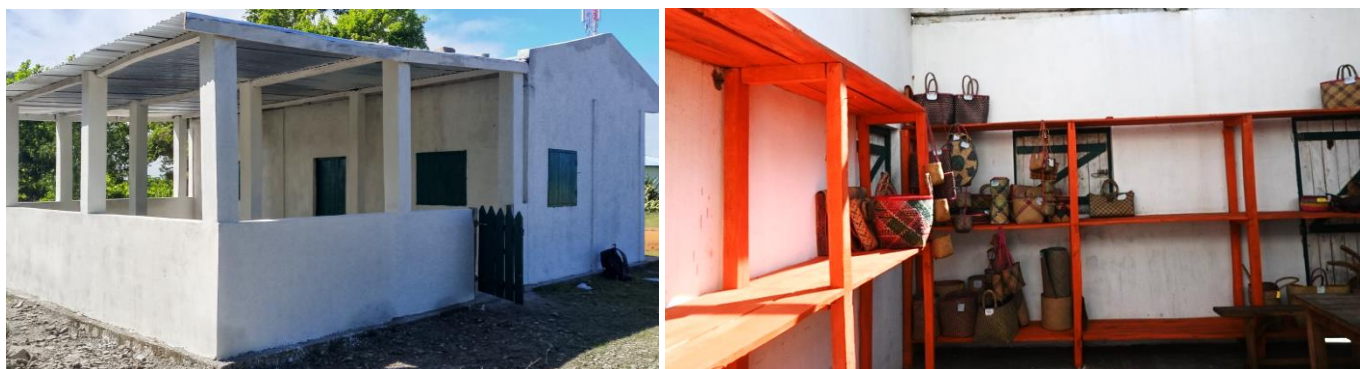
*The Workshop's outdoor weaving area fully constructed and repaired, including reinforced concrete pillars (left). The Workshop repaired and ready to showcase new mahampy products (right).*

The outdoor weaving area, which previously consisted of only a roof and concrete flooring, now includes partial concrete walls of approximately 1.5 metres in height, which are attached to the new cyclone-resistant roof with reinforced concrete pillars. Such pillars provide better support and stability throughout the structure, protecting the weavers and their *mahampy* from extreme wind and rain.
